# Proposed Southern Barossa Winery and Tourist Accommodation

## GEOTECHNICAL INVESTIGATION REPORT

WGA242303-RP-GE-0001\_B

18 August 2025

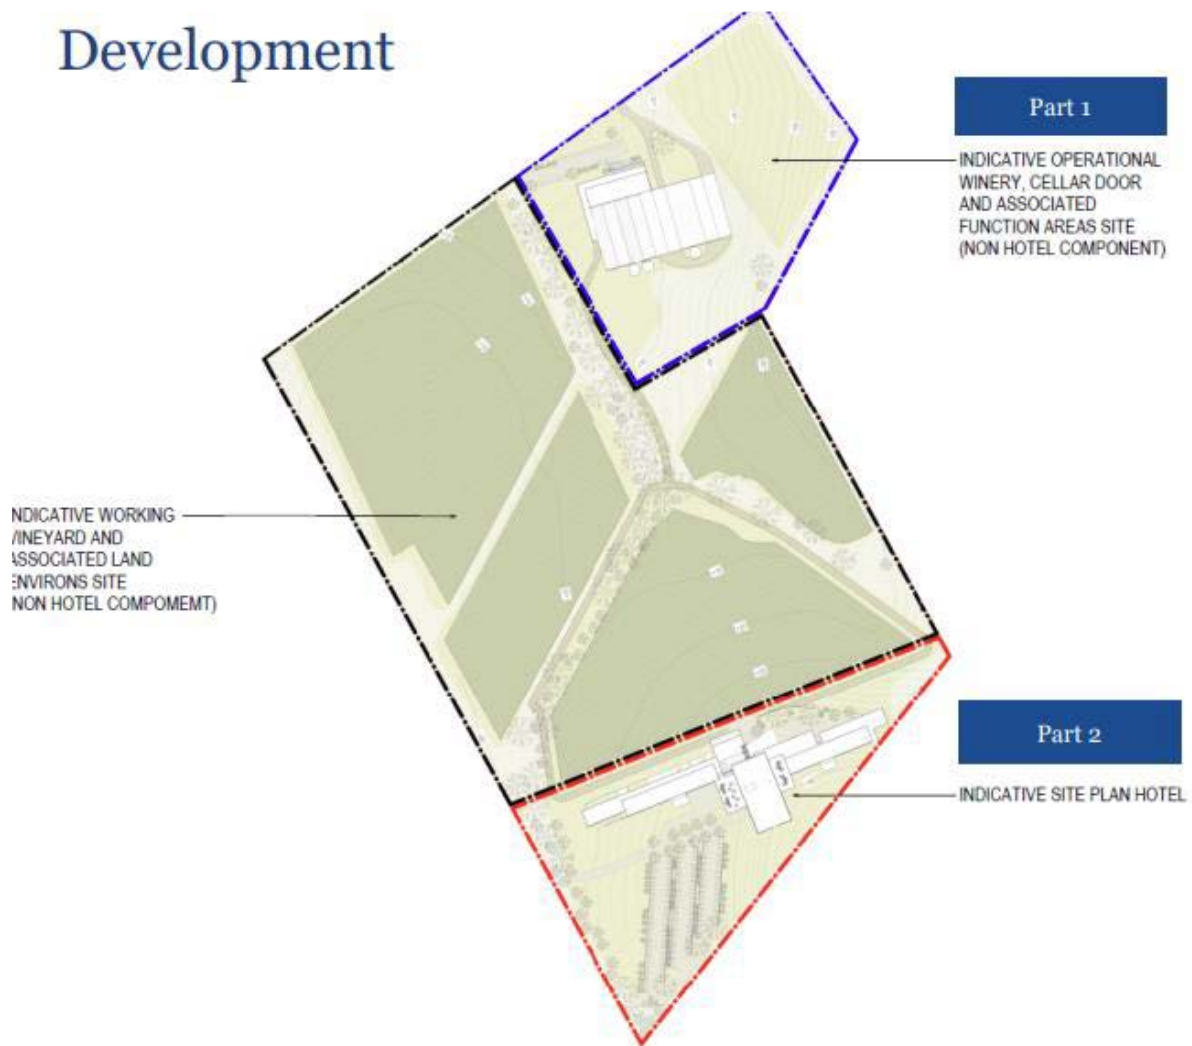
**Figure 4: Site Layout**

The proposed development comprises an on-grade car park and a winery within the north-eastern portion of the site and a multi-storey hotel with an on-grade car park in the south, as shown in Figure 4.

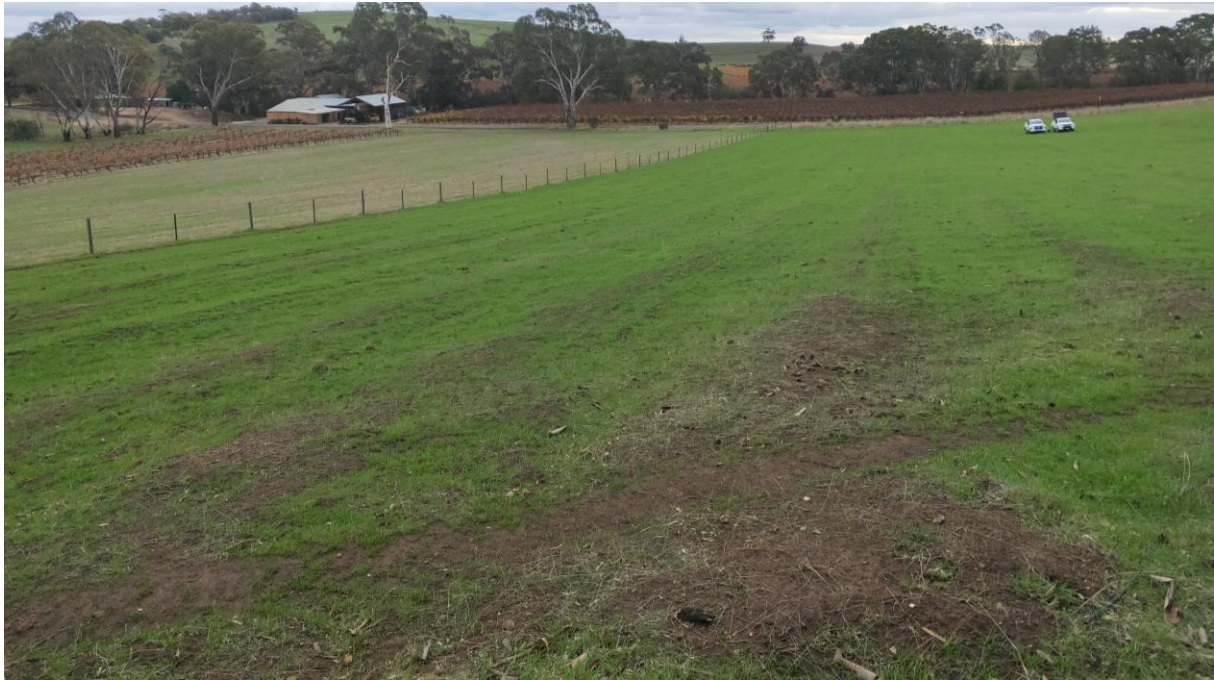
**Figure 4: Typical Site Conditions of the Proposed Car Park and Winery (Facing North-West)**

Numerous trees of varying sizes were present along the eastern boundary and across the site.

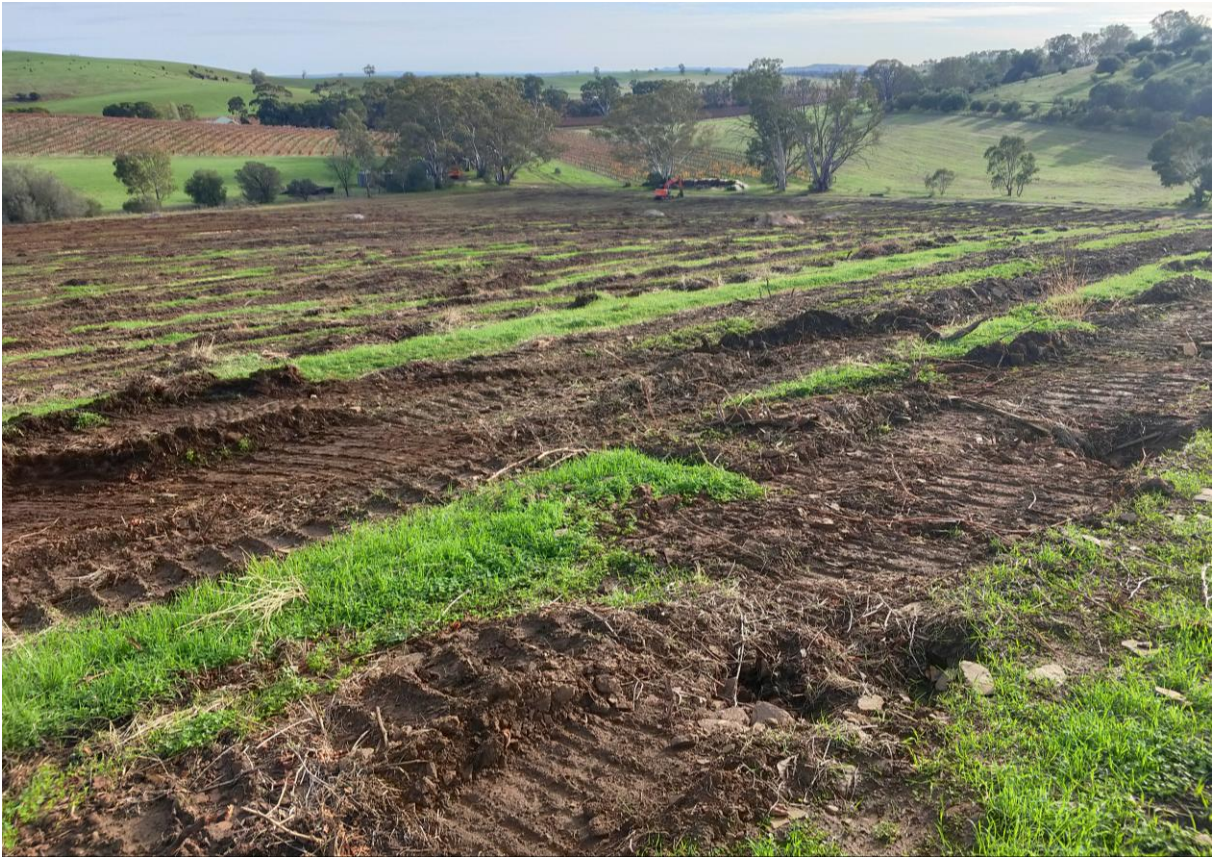
**Figure 6: Typical Site Condition (Facing North)**

Numerous trees of varying sizes were present along watercourses on the site.

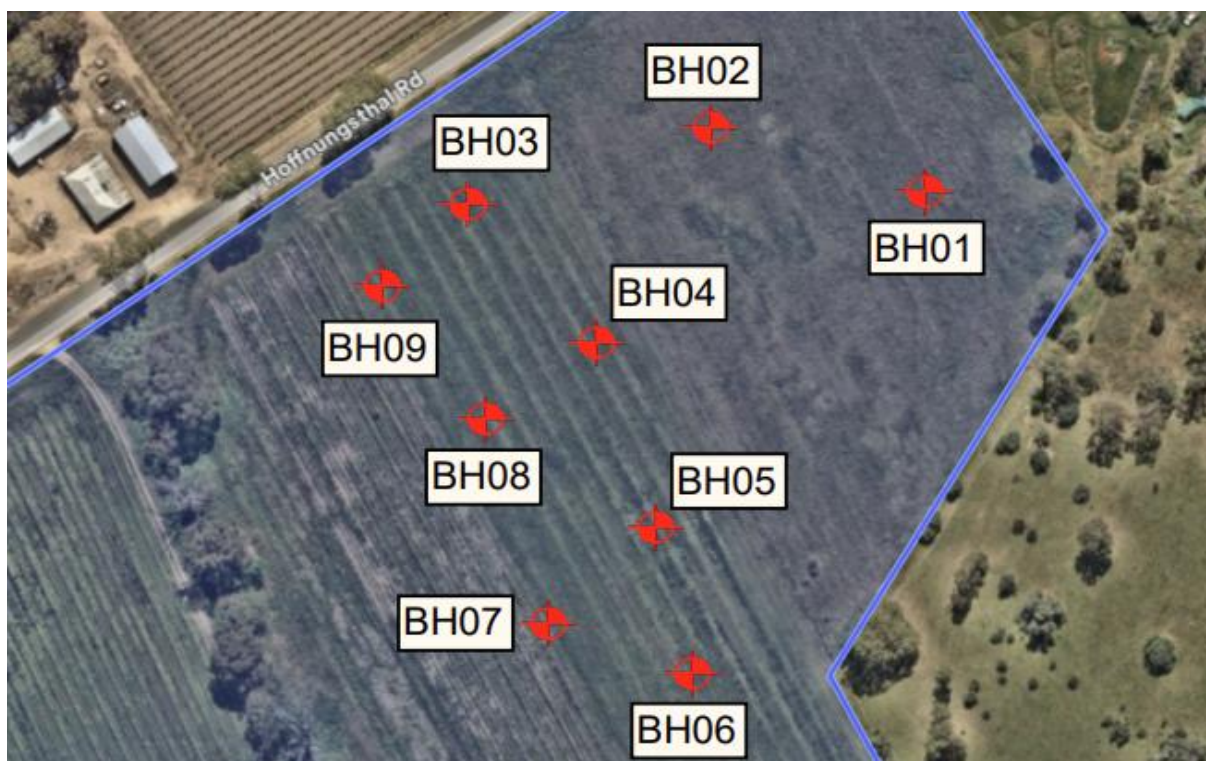
**Figure 9: Previous Boreholes - FMG**

Reference 1 indicates that nine boreholes (denoted BH01 to BH09) were drilled within the footprint of the proposed car park and winery generally to a depth of 3 m, as shown in Figure 9.

Topsoil (clayey silty sand, with rootlets) was encountered in each borehole in Reference 1 to depths ranging from 0.15 m to 0.7 m. The topsoil was underlain by Quaternary aged alluvium to depths ranging from 1.4 m to at least 3 m (borehole termination depth). The alluvium mainly comprised red brown, orange brown and grey brown silty sandy clay of medium to high plasticity and very stiff to hard consistency.

At four borehole locations, the alluvium was underlain by residual soil/weathered bedrock. The residual soil typically recovered as grey, red brown, orange brown clayey sandy silt of low plasticity, with weathered rock fragments. Push tube refusal was encountered in one borehole location at a depth of 3.7 m.

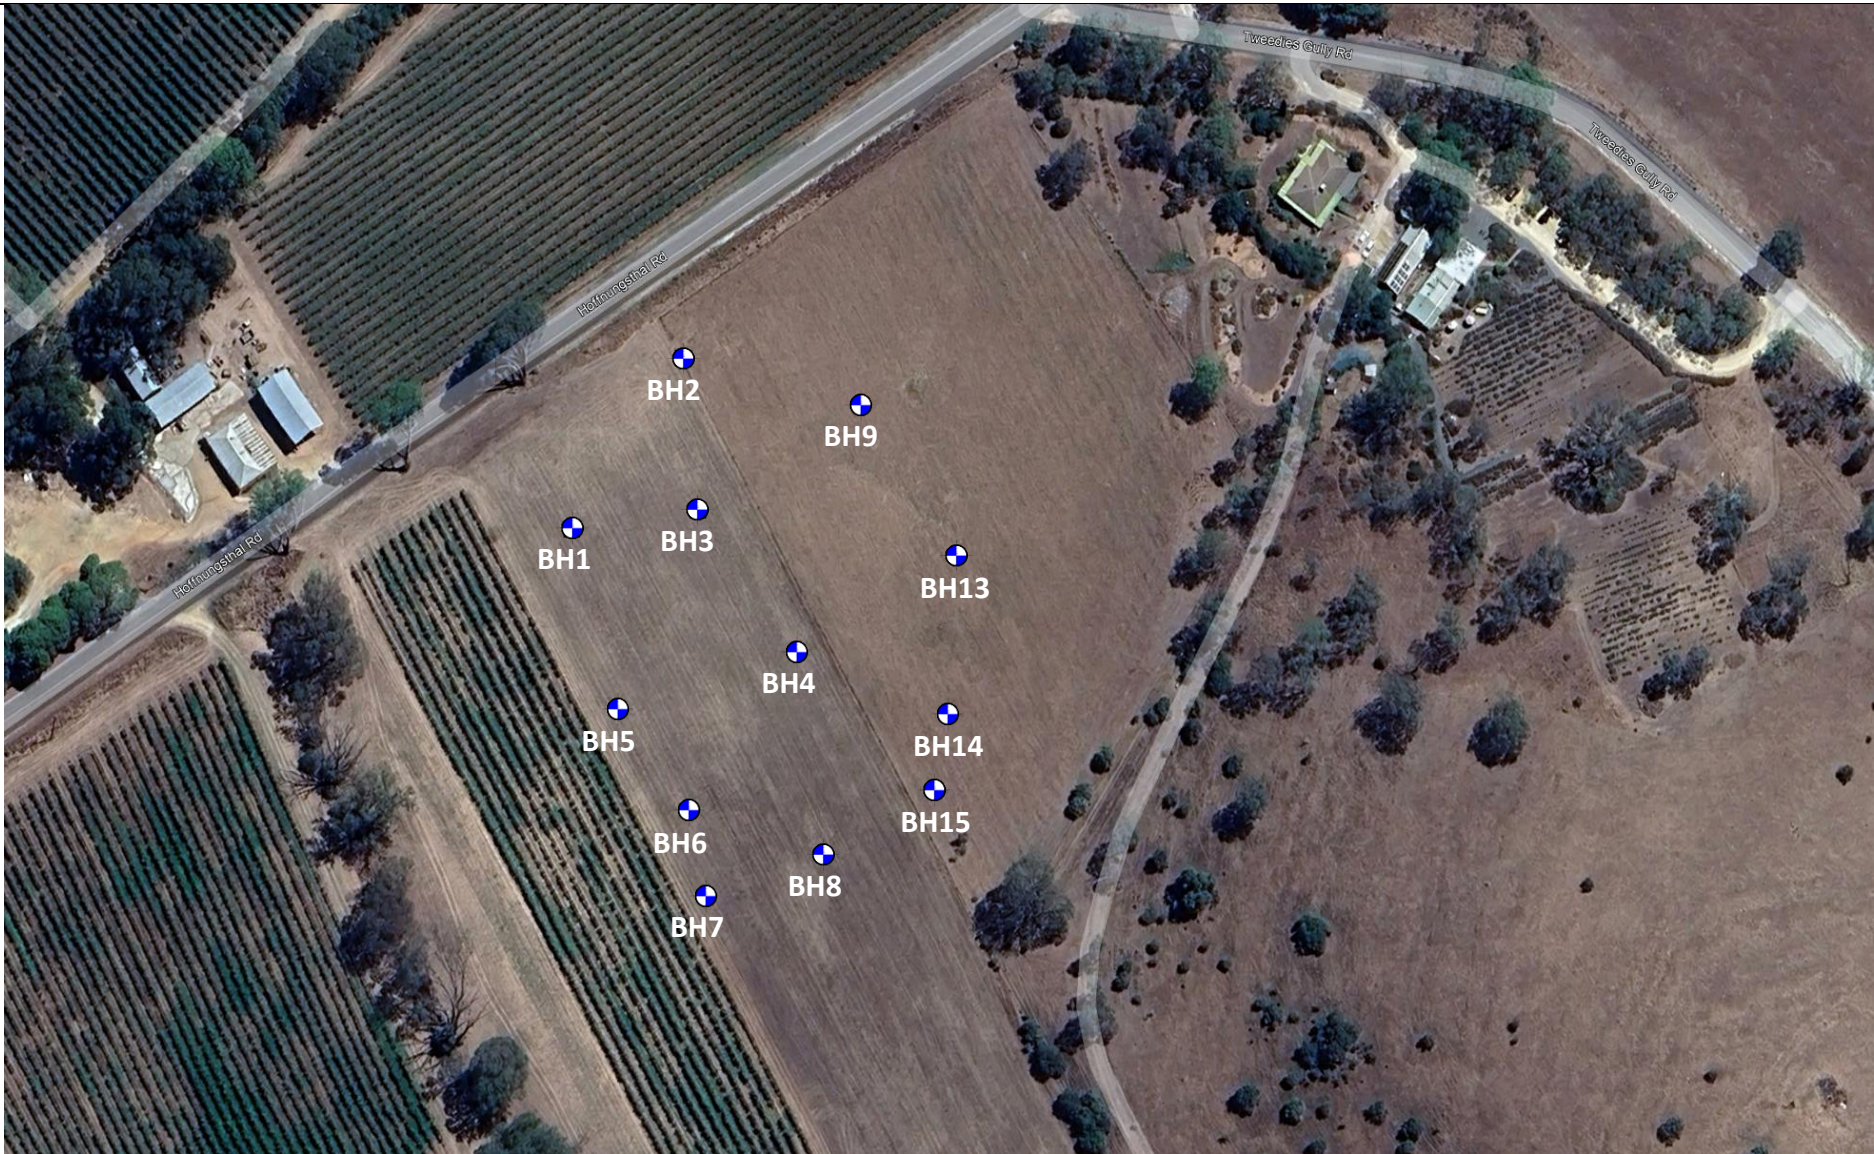
| Project No.: | <b>WGA242303</b> | Ref. | <b>FIGURE A1</b> |

| Title: | <b>BOREHOLE LOCATION PLAN</b> | | |

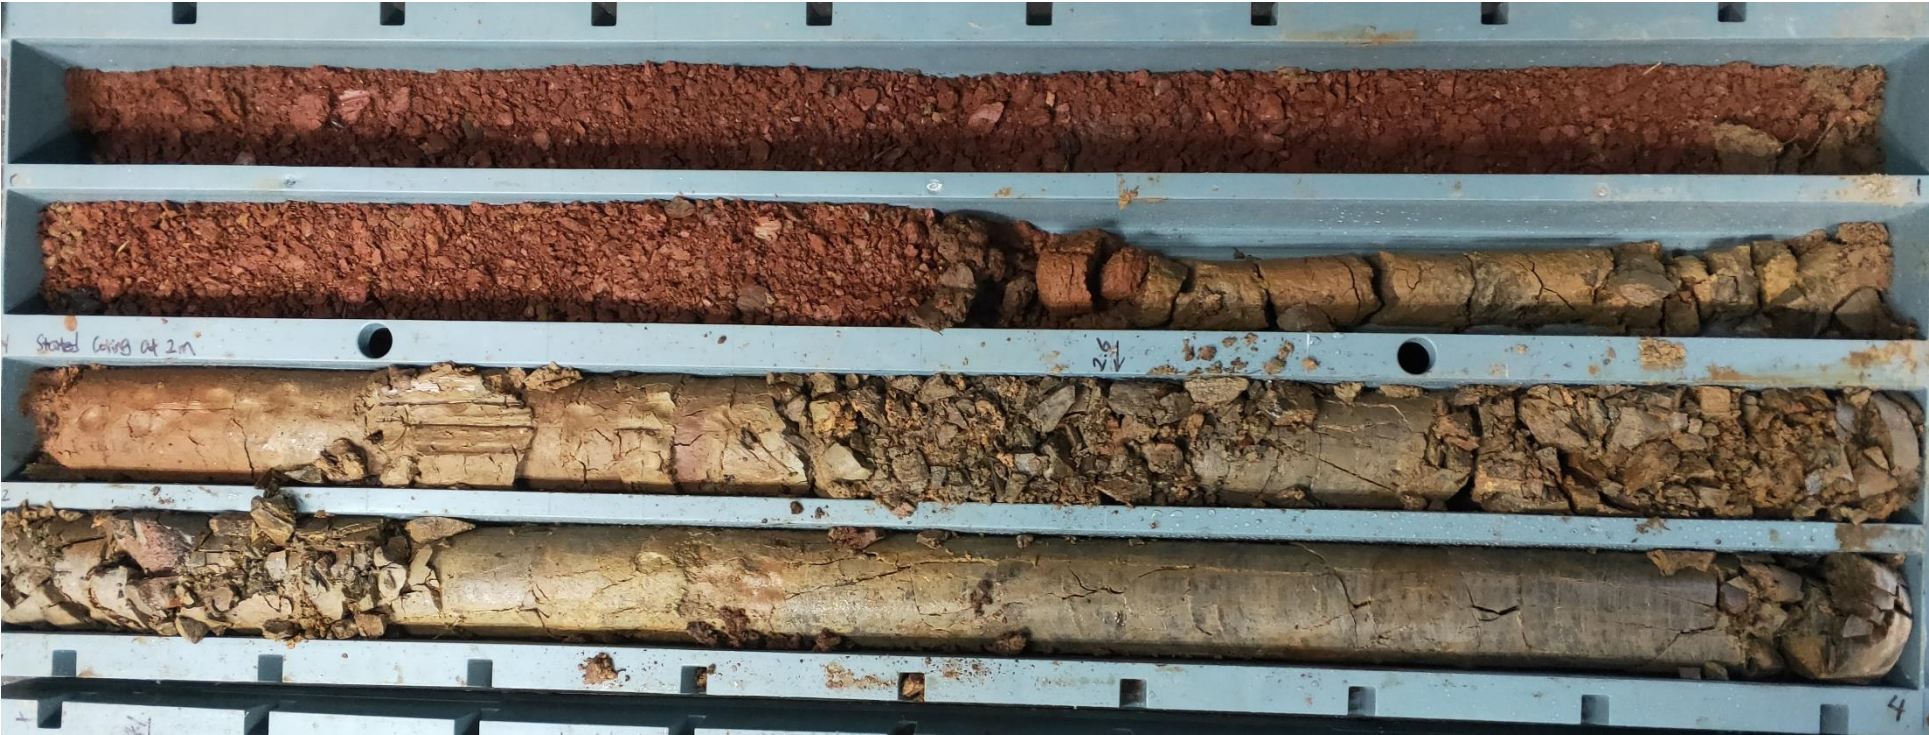
| Title: | CORE PHOTOGRAPHS | Box No: | 1/3 |

| Job No: | WGA242303 | Depth: | 0.0 m – 4.0 m |

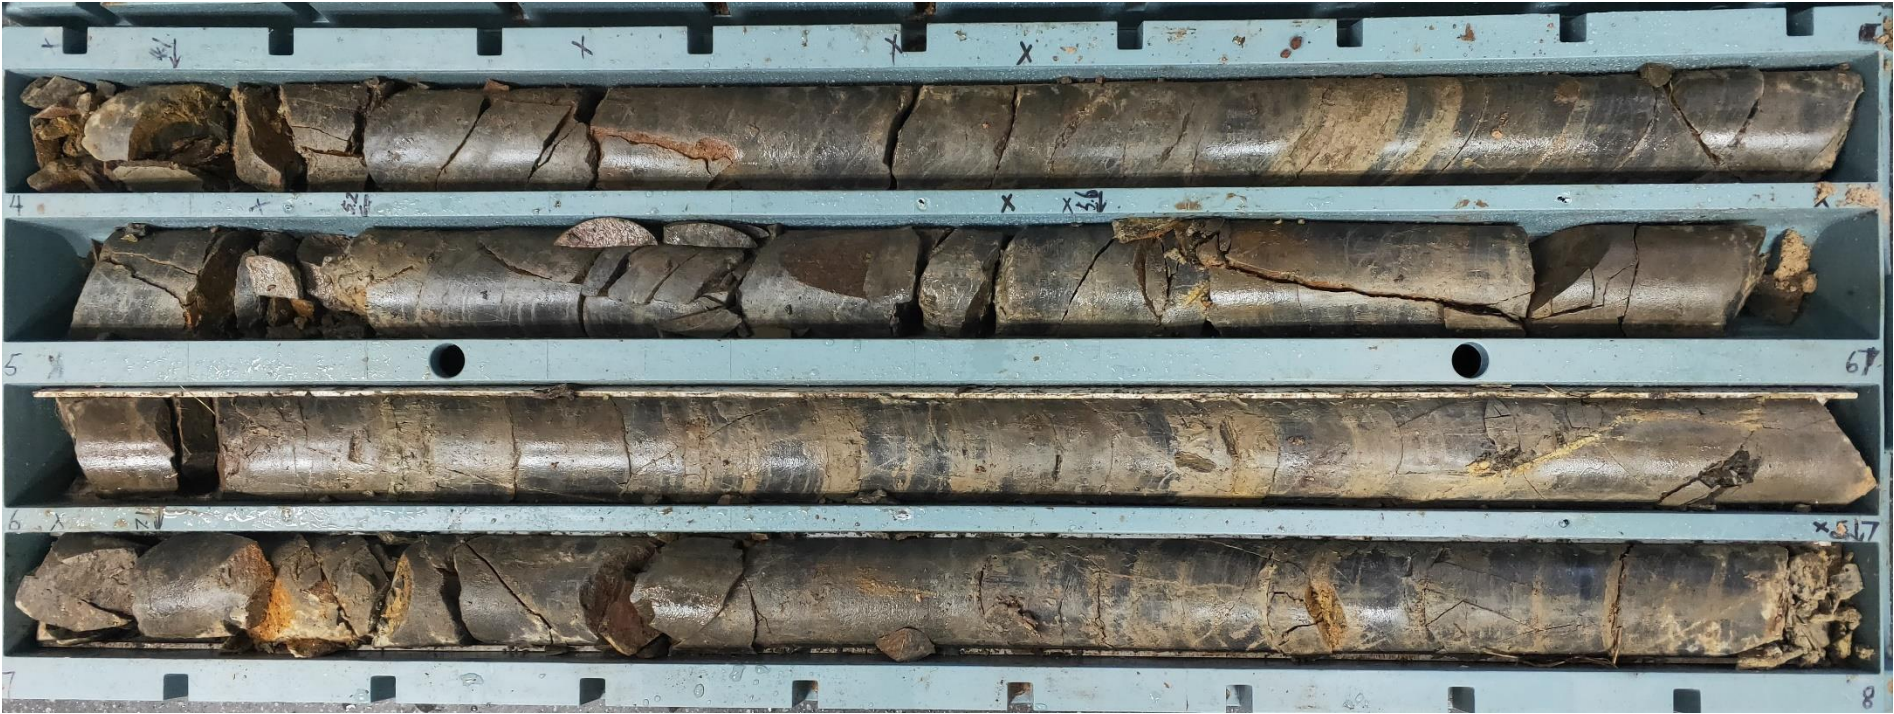
| Title: | CORE PHOTOGRAPHS | Box No: | 2/3 |

| Job No: | WGA242303 | Depth: | 4.0 m – 8.0 m |
