# **Arkaroo Rock Upgrade Project**

## **Project Overview and Activities**

Ikara-Flinders Ranges National Park

Prepared by the Department for Environment and Water  
January 2022

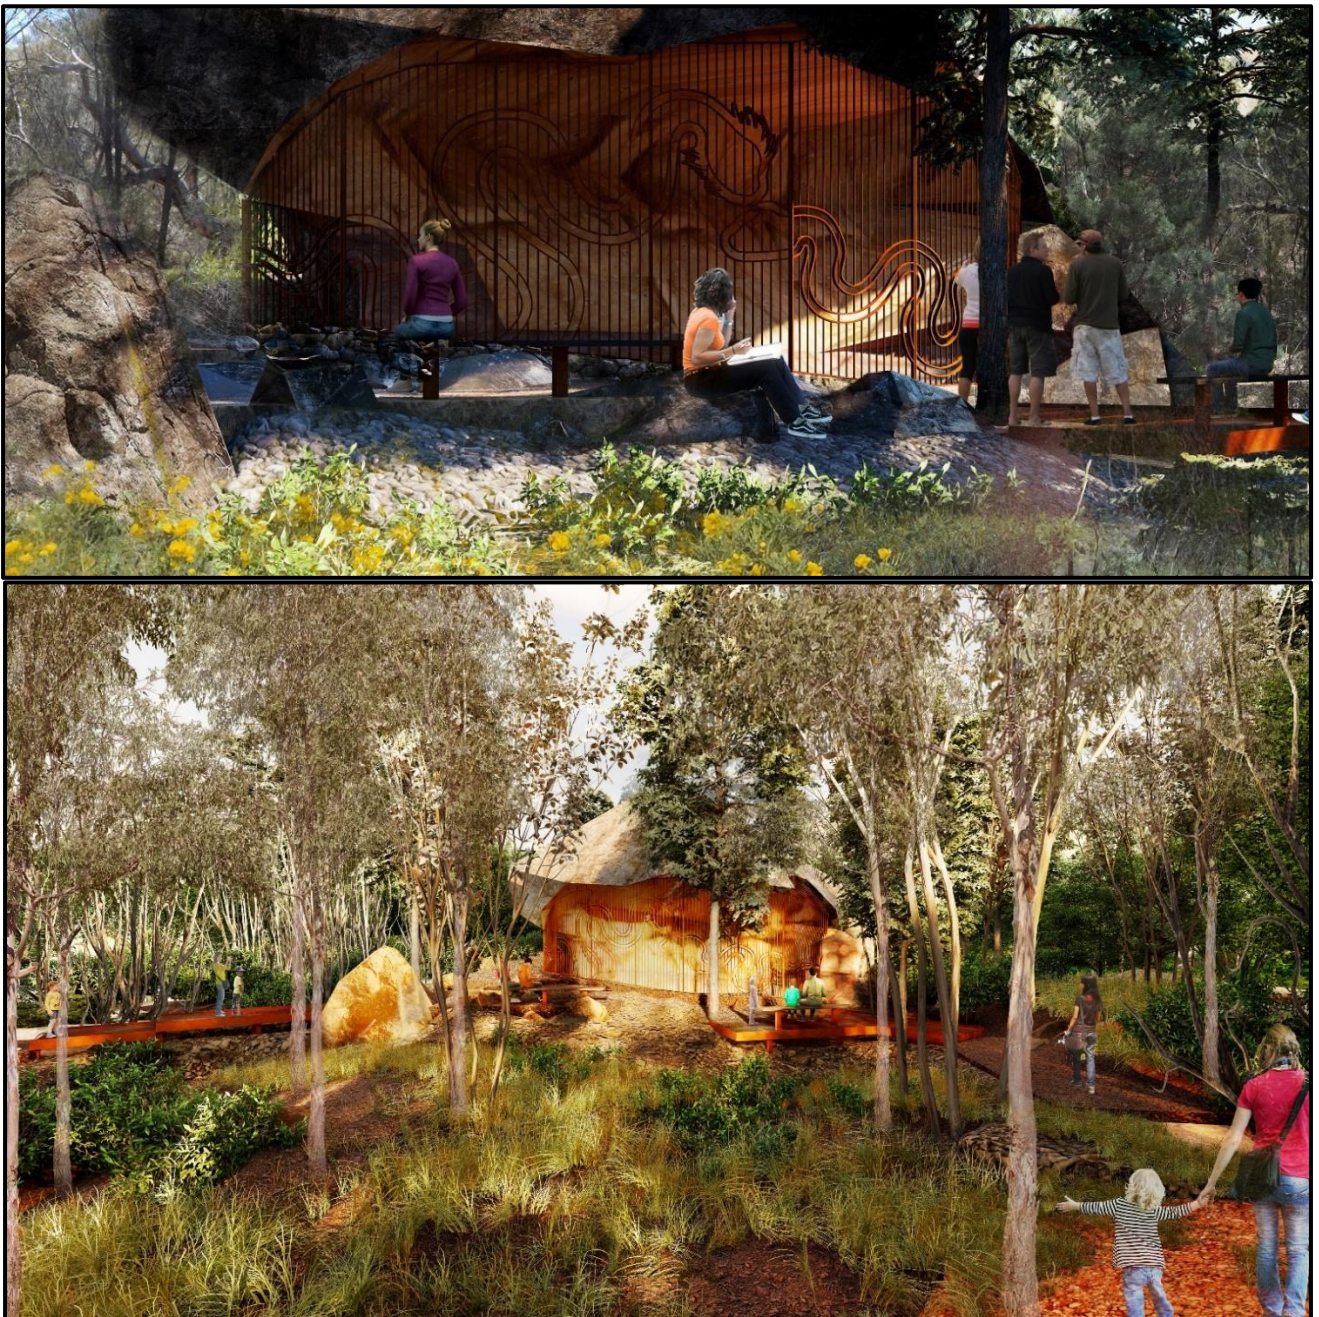
*Figure 4 - Artist's impression of the upgrade provided for illustrative purposes*

Figure 4 shows an artist's impression of the upgrade (once completed). The images are provided for illustrative purposes, noting that the design may change once plans are finalised.
