Site options profile #L1A

# Katarapko Creek - Draft

## Lock 3 Master Plan

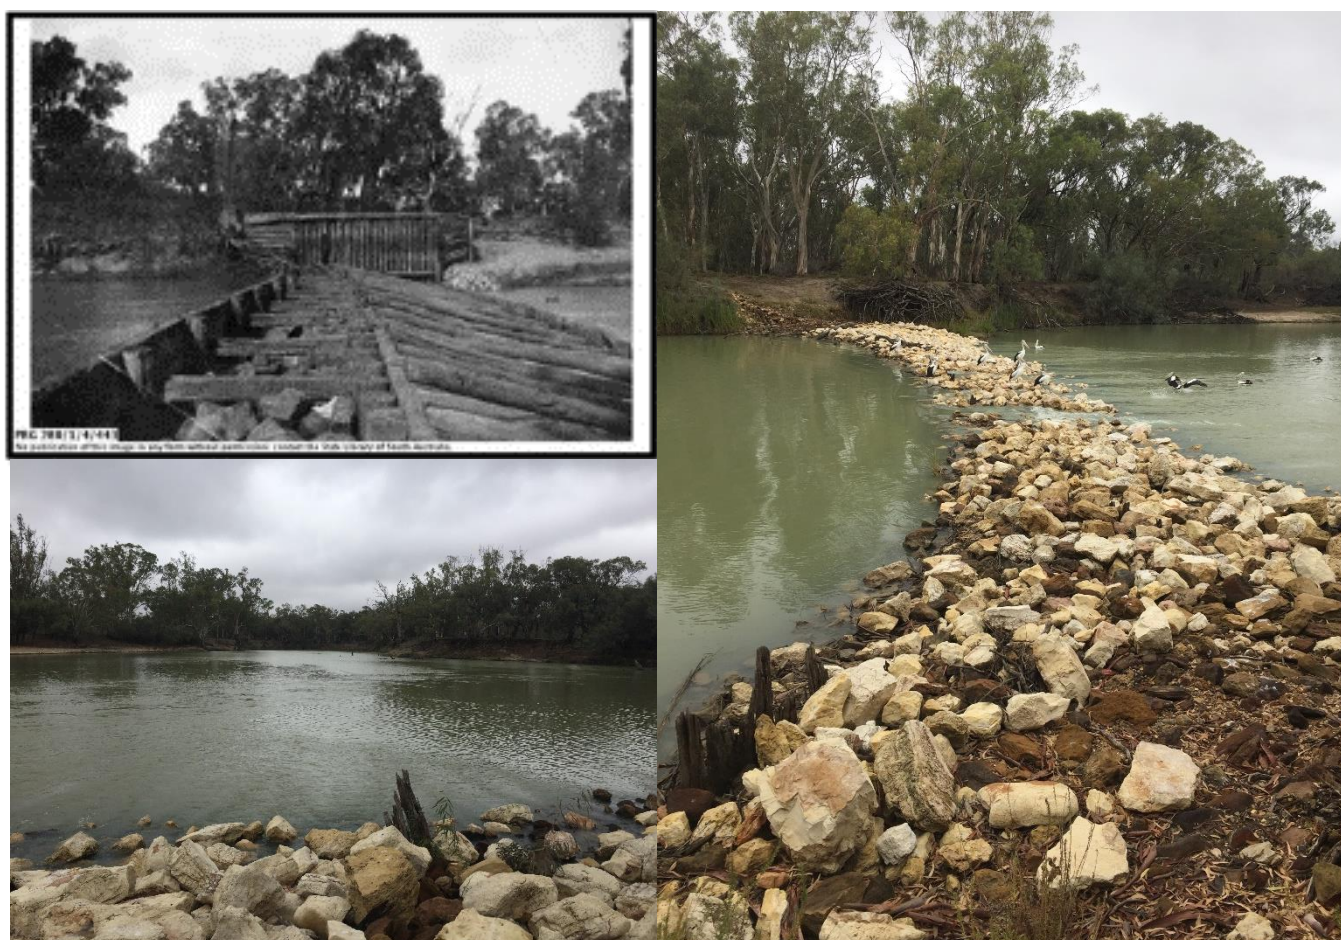
Pictures: Top left, historic picture of the stone-filled timber crib weir; Right, current condition of Stone Weir (March 2020); Bottom left, on top of Stone Weir, looking downstream (March 2020).

The original Stone Weir was constructed circa 1908 and consisted of a stone-filled timber crib weir, which was designed to move more water down the main river channel by holding it back from Katarapko Creek. This kept water levels high for the navigation of steam boats and other vessels. This has created a major barrier for the movement of native fish and restricted flows through the creek.

**Stone Weir:** The Stone Weir was originally constructed in 1908 to ensure adequate water levels were maintained through the Loxton irrigation area during low flow periods. The present weir is a 50 m wide constructed rock filled weir, which affords pedestrian access to Katarapko Island during periods of low flow. There are no regulators or structures which provide fish passage present at the weir during periods of low flow. A large scour hole has developed downstream of the weir that has the potential to threaten the integrity of the structure<sup>6</sup>. The size of the rock remaining at the crest is generally very large (>500 mm) with smaller sized rocks (>200 mm) at the edges of the weir where velocities are lower. Under regulated conditions, water flows through the permeable stone weir and the weir begins to be overtopped at flows greater than 8 000 megalitres per day (ML/day) in the main channel. It is completely inundated when flow reaches approximately 14 000 ML/day in the River Murray. The presence of the weir also lowers water velocity through Katarapko Creek, limiting the suitability of this creek to provide habitat for native fish.

- A large scour hole exists immediately downstream of 'Stone Weir' which presents a construction and design risk.
